April 22, 2004

REPORT SUMMARY

INSPECTION CONDITIONS

CJ Home Inspection
1831 Longboat Dr.
Elk Grove Village, IL 60007

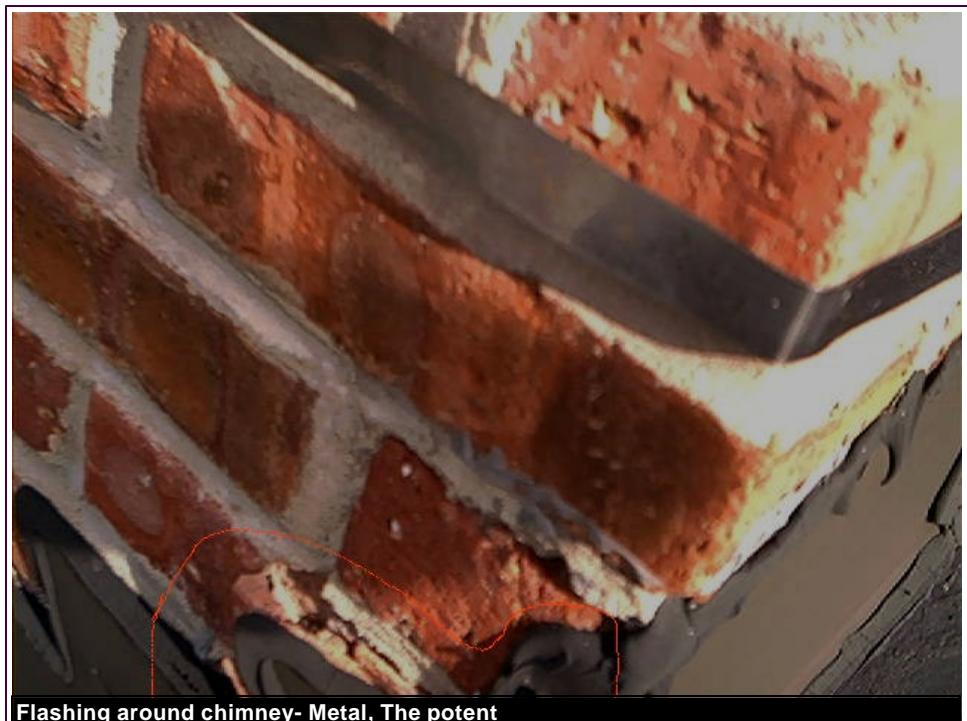
Flashing around chimney- Metal, The potent

Spark arrester noted. Spalling of masonry brick chimney - Chimney missing masonry brick pieces is noted. Chimney is in need of maintenance and repair which may include pointing, replacement of chimney Bricks, and caulking open spaces noted between the chimney and house. Metal flashing around chimney, The potential for water entry is present. A chimney expert should be consulted for further evaluation and repairs as needed.

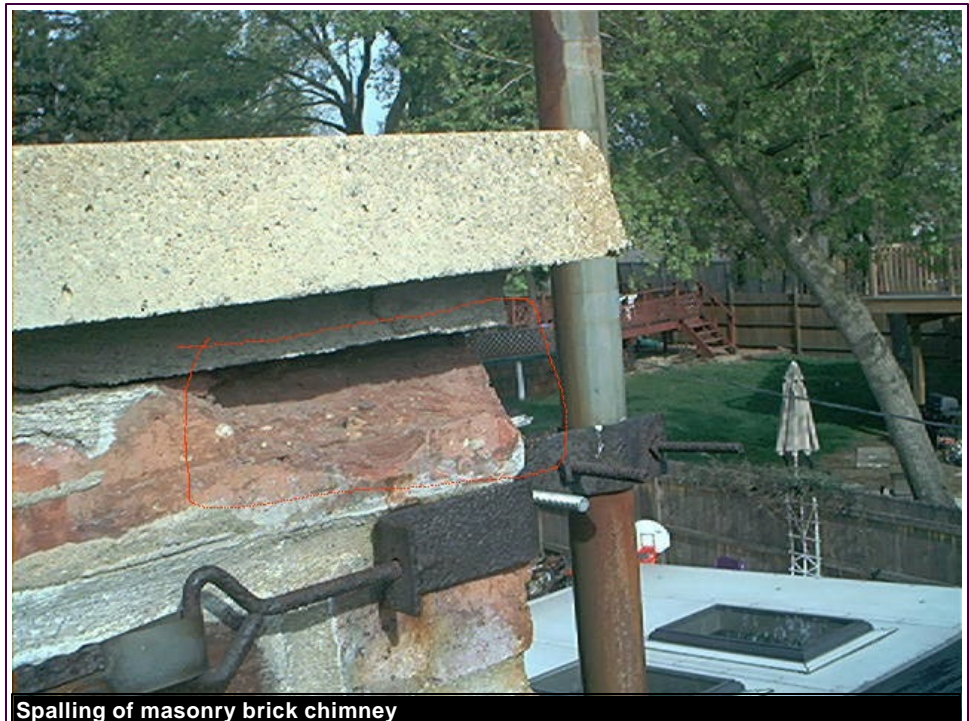
Spalling of masonry brick chimney
Brick.

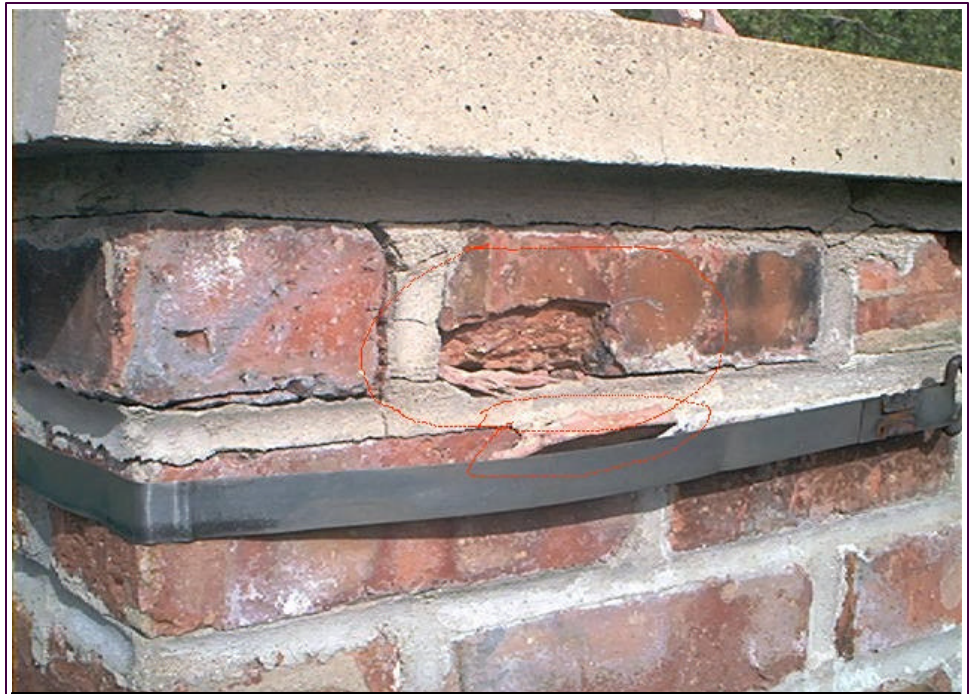
Spalling of masonry brick chimney

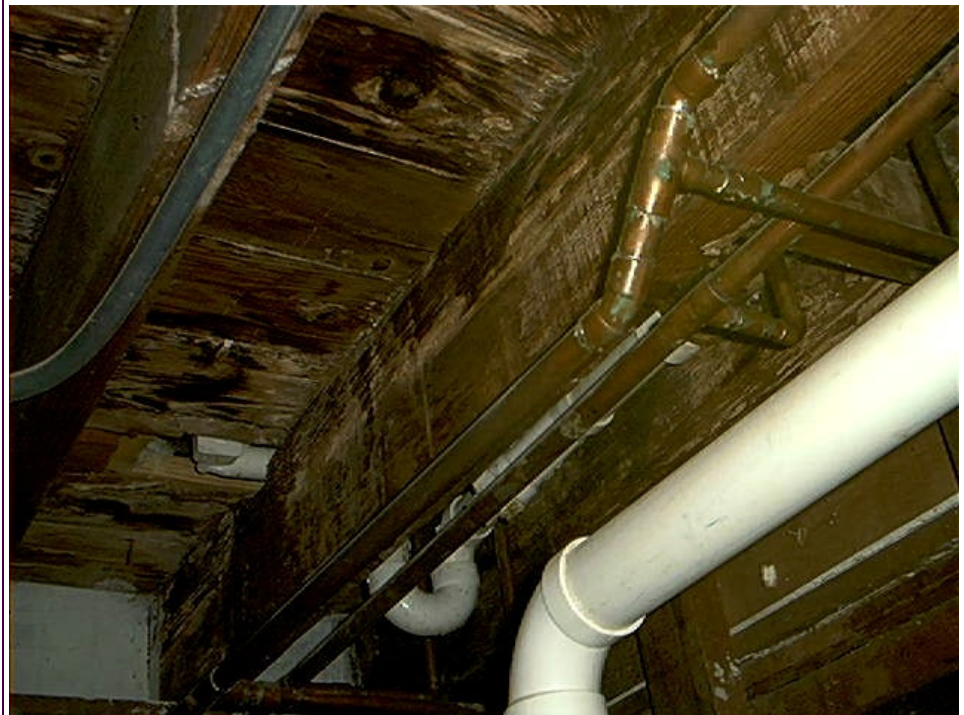
This item is not fully visible. Signs of past leakage is noted to the floor joists and sub floor in fence room.

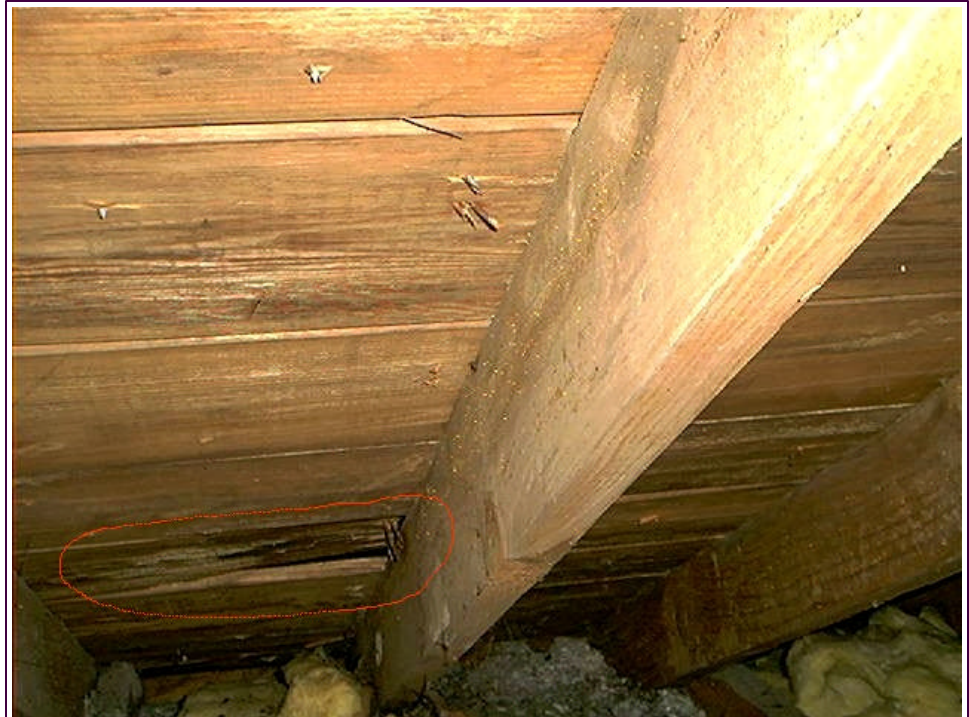
Attic is full size, Conventional framing, Accessible, No walk boards are provided, Minor stains are noted, Unable to determine the status of the stains. Cracking is noted to some of the roof sheathing wood planking, this contributes to high spots in the roof that can be seen from the roof top. This may be caused by the age of the planking and water damage. May need to replace planking next time roof replacement is done.

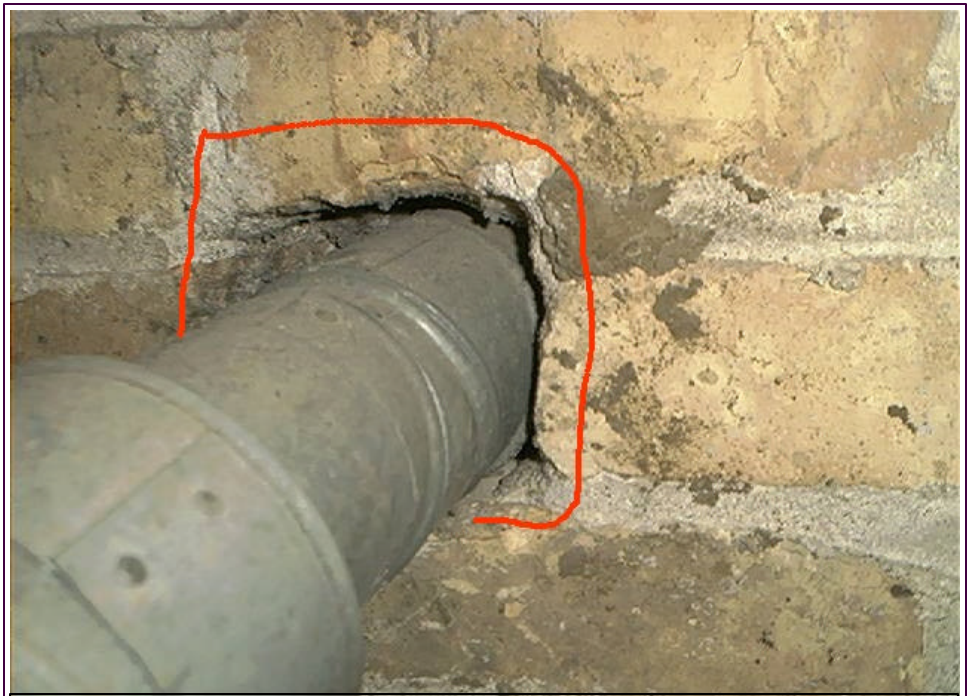
Recommend water heater flue vent be seal u

Pressure relief valve noted, not tested, Flue vent intact, Recommend water heater flue vent be seal up around the flue vent that meats the chimney, to prevent CO gas from entering the building.
