# Home Inspection Report

CJ Home & Mold Inspection Inc.

Hanover Park, IL 60133

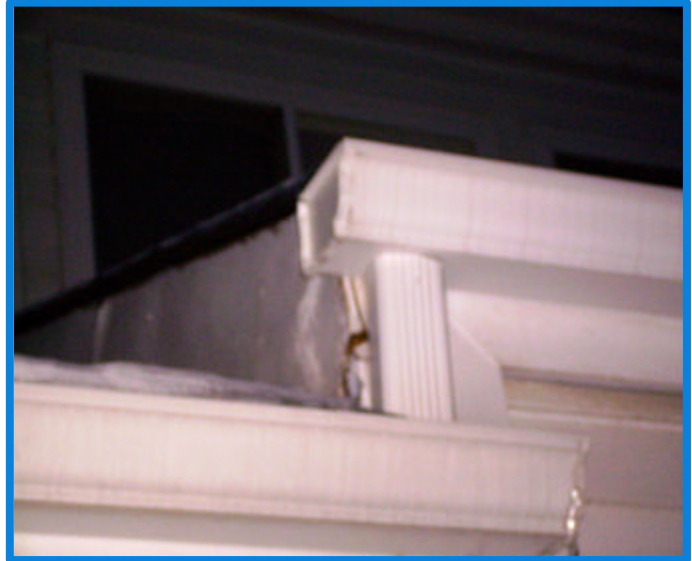
Cracking/hole was noted on the fascia. I recommend that a competent carpenter replace or repair these and repaint them as necessary.

Portions of the exterior woodwork and painted surfaces are showing deterioration to the paint/stain finish. It is important that these surfaces are kept well protected to ensure a maximum service life. The need for exterior painting is now indicated. Subsequent paint maintenance can be carried out as the usual signs of failure such as cracking, peeling or blistering of the painted surface become evident. Typically this would occur at intervals of five to seven years.

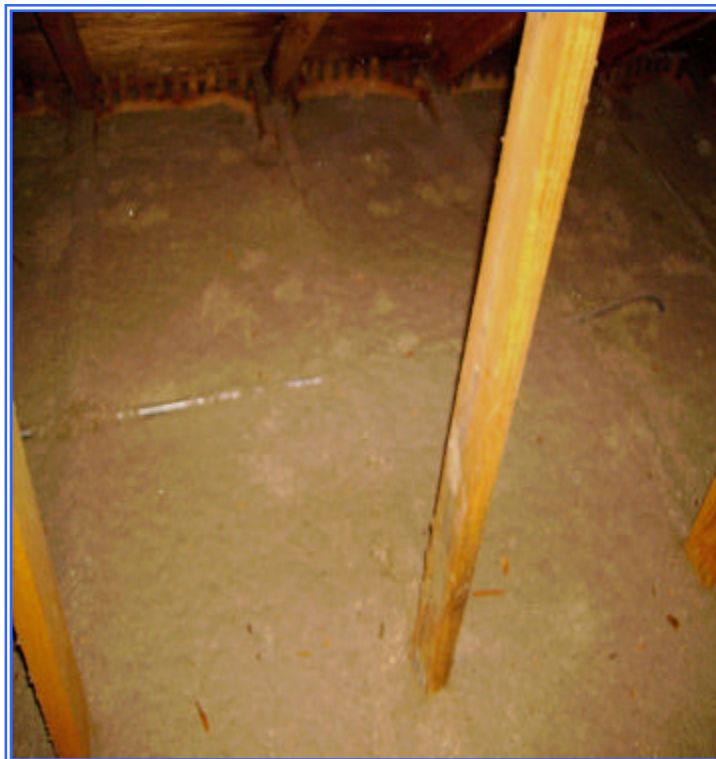
Since it is un-insulated, the attic hatch can result in some energy loss through convection, and some staining of the hatch area may eventually result, when warm house air condenses on the cold hatch and captures dust particles from the air. It is recommended that the hatch be insulated to the same approximate R-value as the rest of the attic.

Insulation is somewhat compacted and the true R-factor at this point in time may be substantially less than that originally installed. Installation of additional insulation is recommended. Recommend additional insulation in the attic area.

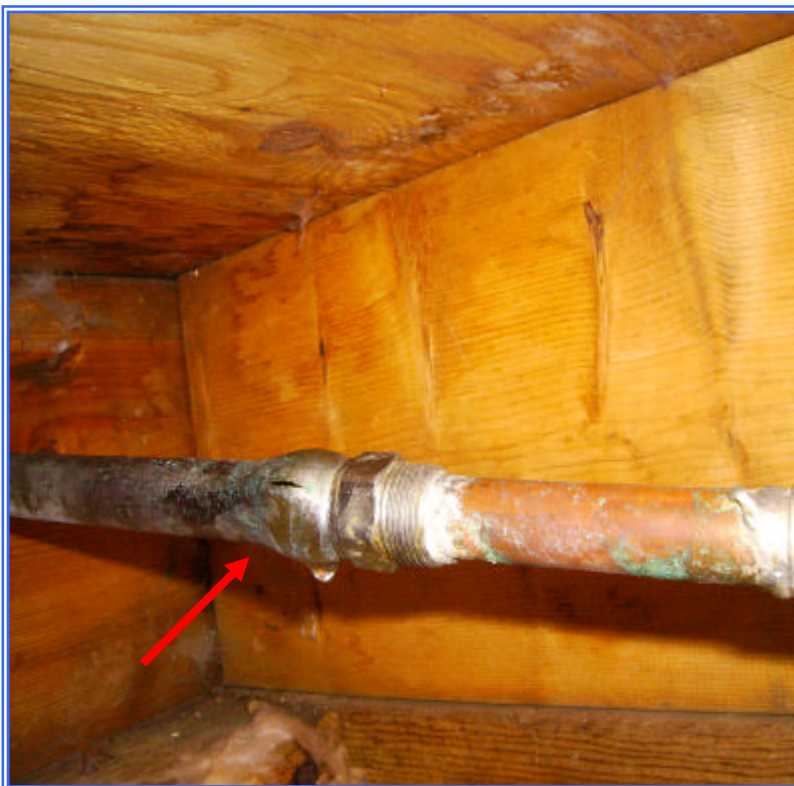
I noted bulging pipe and cracked wall in the hose faucet in crawl space, leakage was noted. A bulge in a pipe is typically an indicator that the pipe had been frozen at some time in the past. This kind of distortion can seriously weaken a pipe wall, making it prone to failure if it should freeze in the future. I recommend having the affected section of plumbing replaced and then insulated.

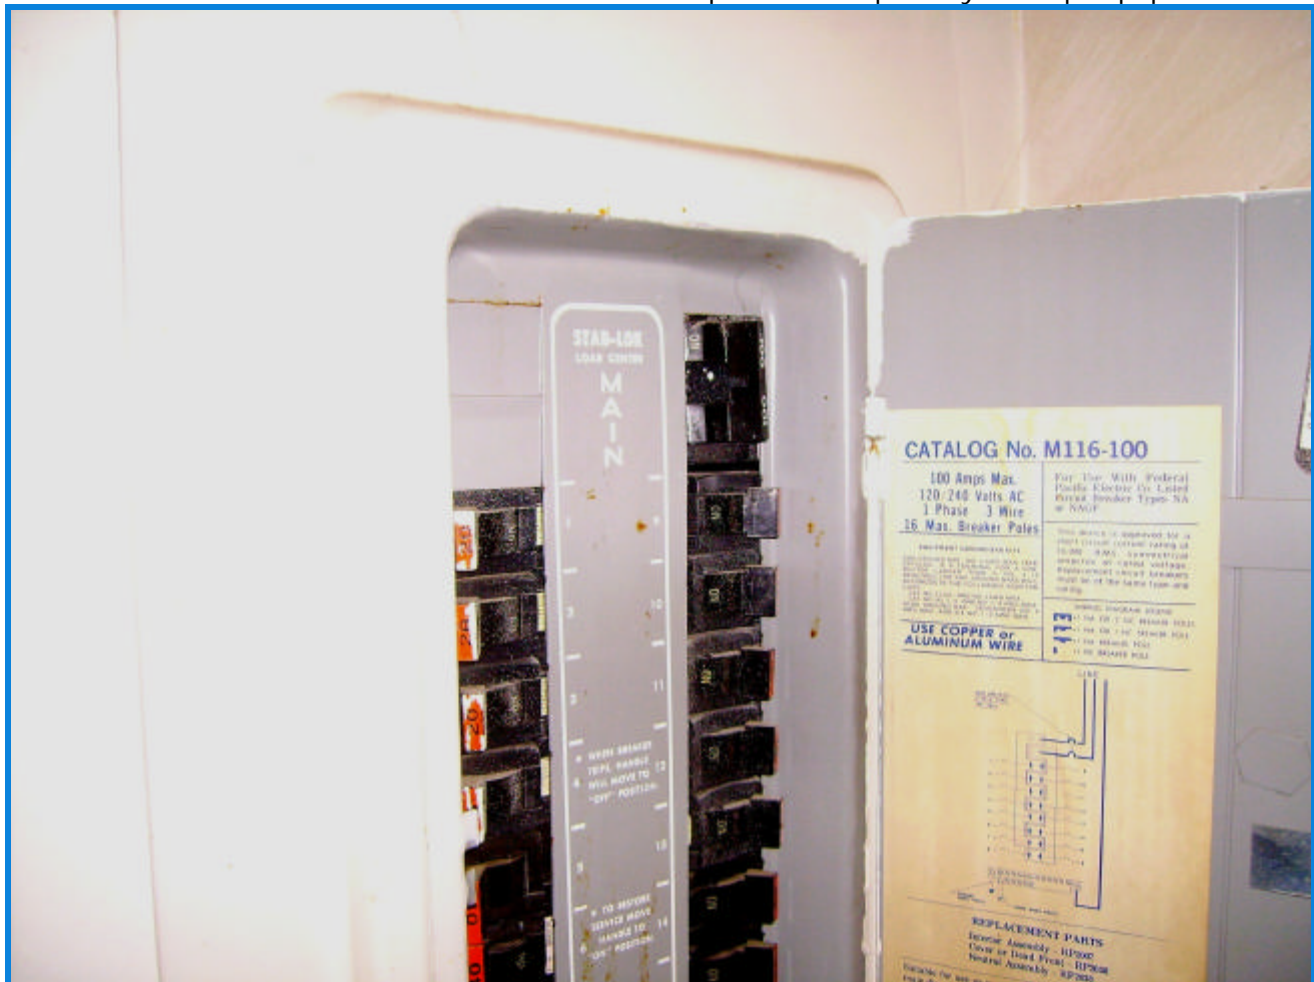
No ground fault circuit interrupters (GFCI) were found in the Garage, front of the residence and back of the residence.

I have observed a Federal Pacific Electric "Stab-Lok" service panel in the house. This panel is a latent fire hazard: its circuit breakers may fail to trip in response to an over current or a short circuit. Failure of a circuit breaker to trip can result in a fire, property damage, or personal injury. A circuit breaker that may not trip does not afford the protection that is intended and required. Simply replacing the circuit breakers is not a reliable repair. The panel should be replaced. Additional information can be read on internet at <http://www.inspect-ny.com/fpe/fpepanel.htm>

This is a list of only those items readily apparent during my limited inspection of the electrical system. A further examination by a qualified electrician is recommended.

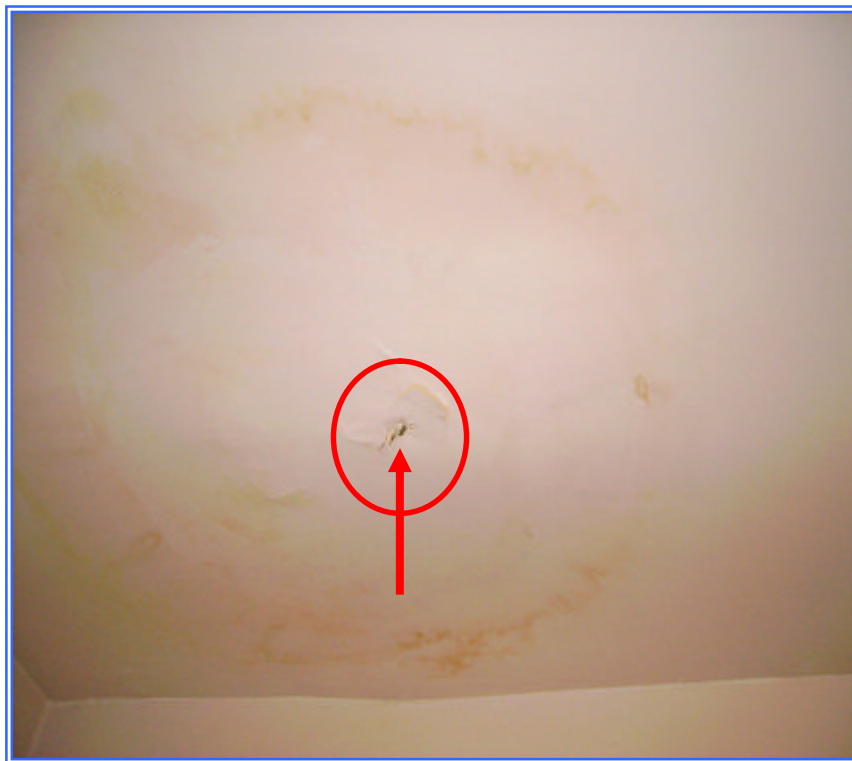
There are water-stained ceilings that appear to be the result of water intrusion, possibly from flashing or roof leaks or interior plumbing fixtures or water lines. There is no indication that the stains are the result of active leaks. It is unknown how these have affected unseen areas, and whether or not there could be structural damage caused by rot. Recommendation: Confirm from seller if the stains are related to a previously repaired problem or obtain evaluation for the source of the moisture by licensed roofing, siding or plumbing contractor and repair as appropriate.

There are holes in the ceilings and water-stained was noted in the Landry room that needs to be repaired. I recommend repairs by an experienced handyperson or drywall professional. The water-stain appears to be from the upstairs toilet past leakage at one time.
