April 22, 2004

REPORT SUMMARY

INSPECTION CONDITIONS

CJ Home Inspection
1831 Longboat Dr.
Elk Grove Village, IL 60007

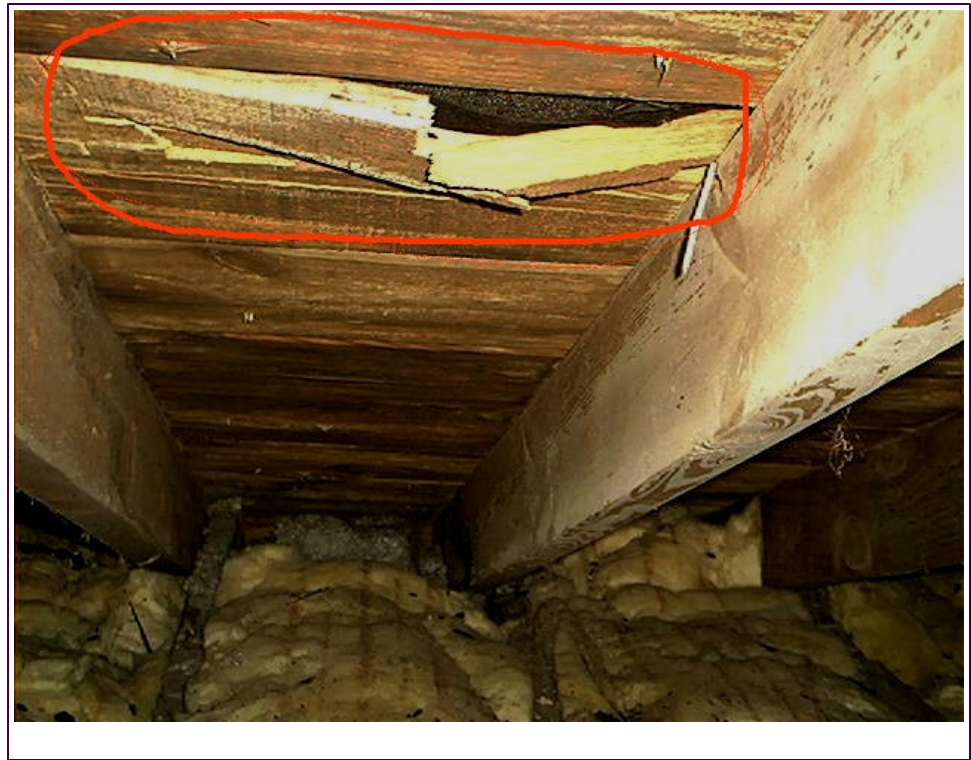
Attic is full size, Conventional framing, Accessible, No walk boards are provided, Minor stains are noted, Unable to determine the status of the stains. Cracking is noted to some of the roof sheathing wood planking, this contributes to high spots in the roof that can be seen from the roof top. This may be caused by the age of the planking and water damage. May need to replace planking next time roof replacement is done.
